PROPERTY INFORMATION

Street Address: 123456 Main Street
City: Waddell **State:** AZ **Zip Code:** 85355

Client Name(s): John and Mary Homebuyer
VHI Report # 98456
Inspected By: Dennis D. Inspector - Certification #00000

Inspection Date: 6/3/10

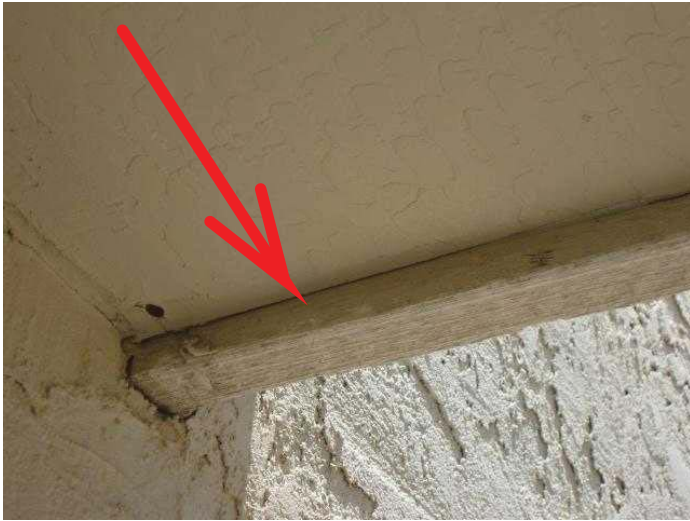
- 2. Porch/Patio Ceiling(s):** Drywall
Gaps observed at the rear patio ceiling perimeter. Suggest caulking as necessary.

Seal gaps at patio ceiling

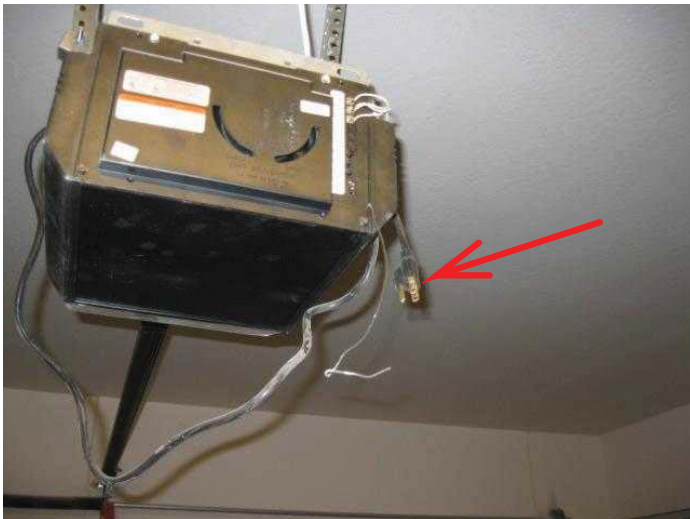
- 1. Garage Door Opener:** Chain Drive
Opener unplugged. Not tested. Suggest having the opener demonstrated in full operating condition prior to the close of escrow.

Garage door opener unplugged

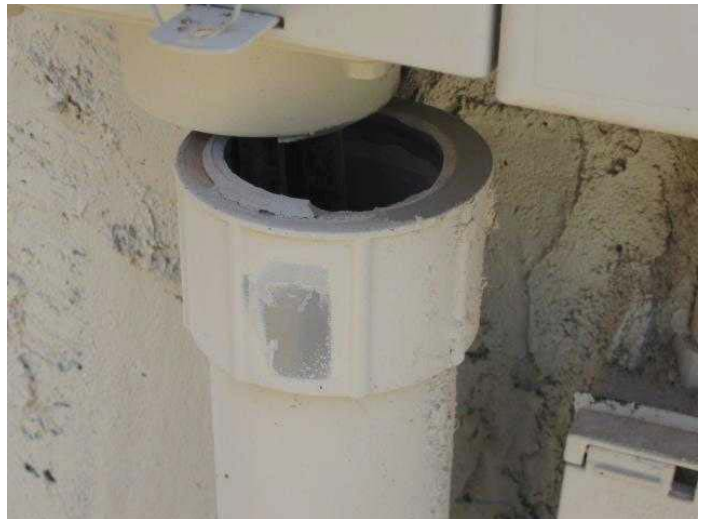
- 6. Service Size:** Amps: 200 Amps Volts: 120/240 VAC
- 1 2 3 NPNI**
7. **Service Entrance:** Underground
Service entrance conduit is damaged and wires are exposed. Suggest repair as necessary.

Damaged electrical service entrance conduit

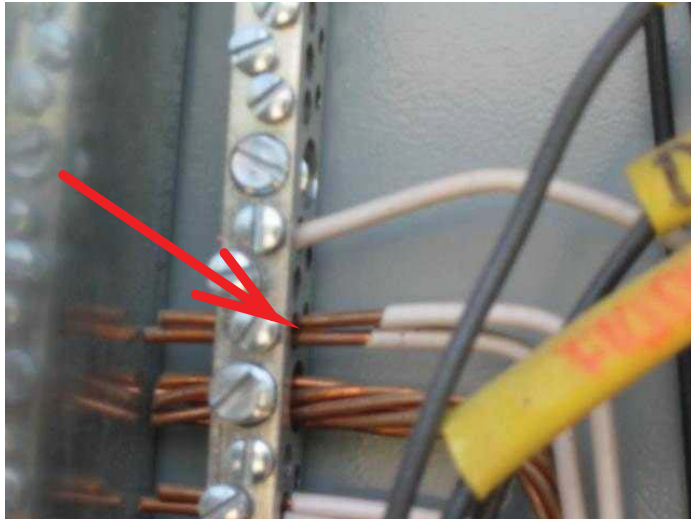
- 1. Location:** Front Left Exterior
- 1 2 3 NPNI**
2. **Manufacturer:** Cutler-Hammer
Double tapped neutral lugs observed in the main panel. Suggest separating the wires to individual lugs by a licensed electrician.
3. **Main Breaker Size:** 200 Amps
4. **Breakers:** CU/AL
The breaker labeled "Upstairs Lighting" is tripped and does not reset. Suggest further evaluation by a licensed electrician and repair as necessary.
5. **Ground:** Present - Termination Unknown

Double lugged neutrals in main panel

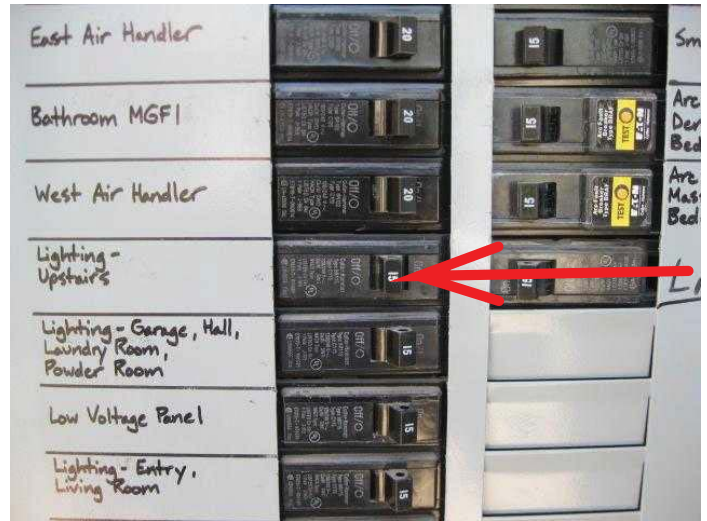
1. **Breakers:** CU/AL
The breaker labeled "Upstairs Lighting" is tripped and does not reset. Suggest further evaluation by a licensed electrician and repair as necessary.
2. **120 VAC Outlets**
Outlets have no power at:
 - 1) The upstairs front left bedroom
 - 2) The loftSuggest further evaluation and repair as necessary by a licensed electrician.
Damaged outlet cover at the loft. Replace as necessary.
3. **Lighting** 120 VAC
Lighting is inoperative at:
 - 1) The stairway
 - 2) The loft
 - 3) The kitchenSuggest further evaluation by a licensed electrician and repair as necessary.

Breaker tripped

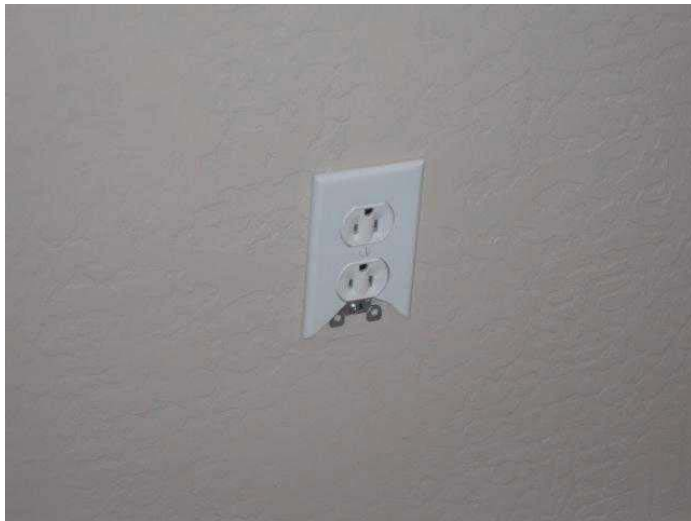
12. **120 VAC Outlets**
Outlets have no power at:
1) The upstairs front left bedroom
2) The loft
Suggest further evaluation and repair as necessary by a licensed electrician.
Damaged outlet cover at the loft. Replace as necessary.

Damaged outlet cover at the loft

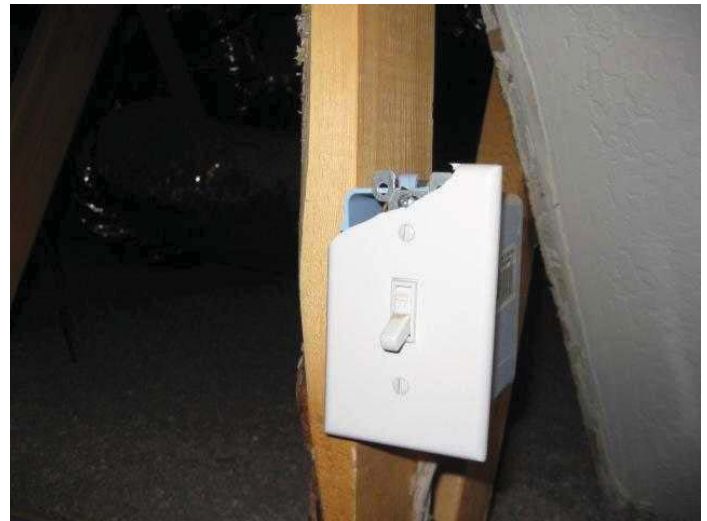
16. **Switches**
Damaged switch cover at the attic. Replace as necessary.
17. **Doorbell** Hard Wired
18. **Smoke Detectors:** Present
Chirping noted at smoke detector(s). This indicates the need to replace the batteries. Replace batteries as necessary.
Visual inspection only. We do not test smoke detectors or carbon monoxide detectors. WE SUGGEST TESTING UNIT(S) UPON MOVE-IN, and testing monthly.

Damaged switch cover at the attic

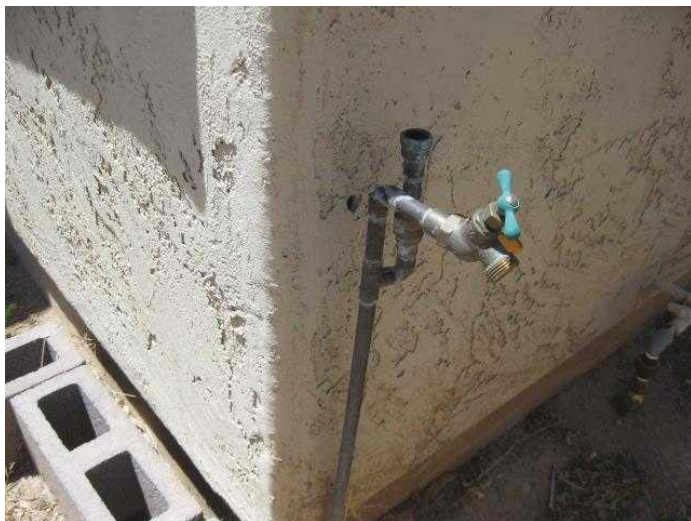
- 7. Hose Bibs:**
Anti siphon valve missing at the front left hose bib. Suggest adding for safety.
Hose bib piping unsecured at the left rear. Suggest securing the piping to the wall.

Hose bib piping not secured to the wall

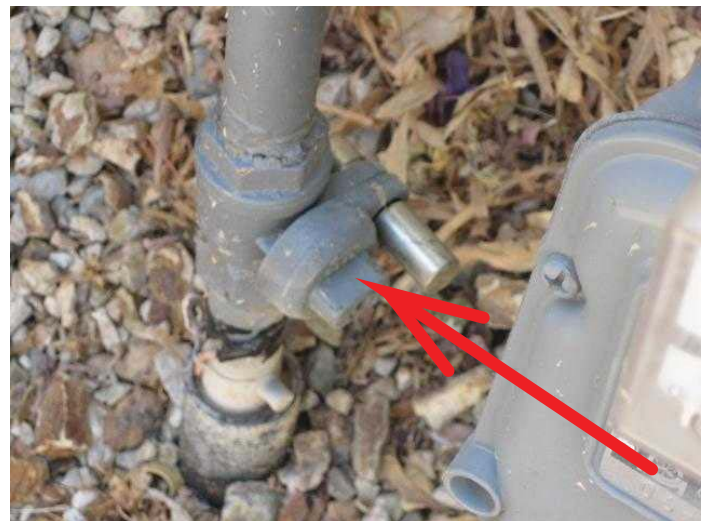
Gas off - Meter locked

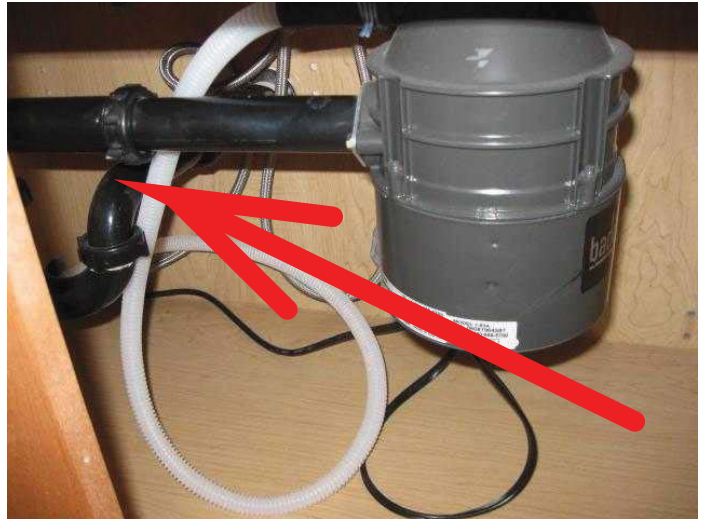
No sanitary loop observed (helps prevent back flow of water from the disposal into the dishwasher).
Suggest installing a sanitary loop. |

No sanitary loop at dishwasher drain
