# Inspection Report

**Property Address:**  
55432 E Sample Dr  
Scottsdale AZ 85205

## Valley Home Inspections

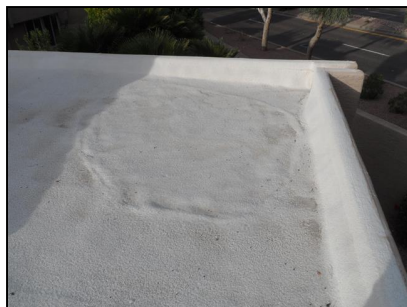
(1) Evidence of repairs were noted at the flat roof. Refer to the seller regarding the repairs and all known prior leak conditions.

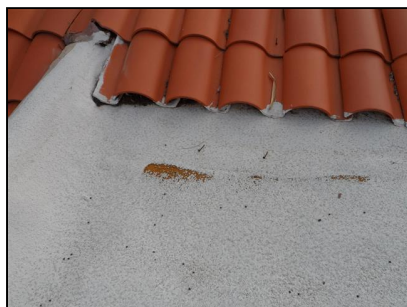
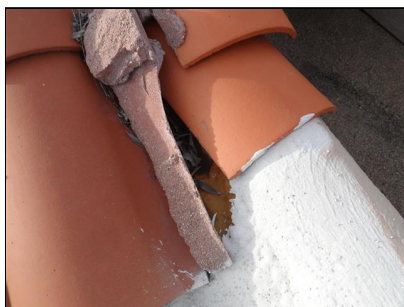
(2) Wear and damage was noted at the foam roof area. The elastomeric covering was noted deteriorated at a few areas. This is a potential leak condition. Recommend further evaluation and repair by a qualified professional.

(2) Wear and damage was noted at the foam roof area. The elastomeric covering was noted deteriorated at a few areas. This is a potential leak condition. Recommend further evaluation and repair by a qualified professional.

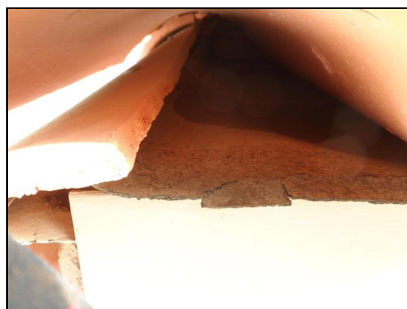
(3) Tile roof underlayment has a typical life expectancy of 20 to 30 years and can often break down even sooner. The full condition of the underlayment felt is not visible per our inspection requirements. No leaks or moisture stains were noted at the tile roof portions. We recommend that the underlayment be further evaluated by a qualified specialist. We also recommend that you refer to the seller regarding all prior repairs or leak conditions.

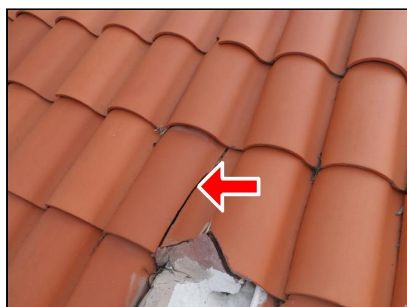
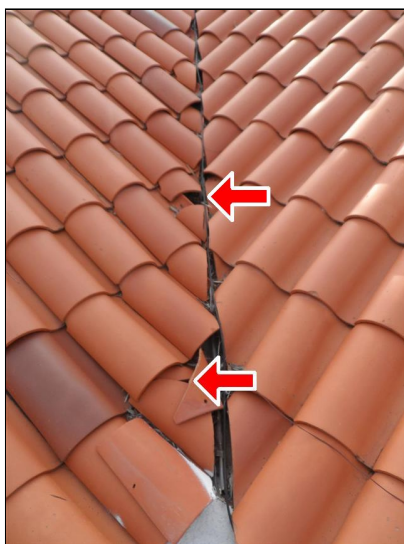
(4) Three cracked tiles were noted at the main roof. This can be a potential leak condition. Recommend further evaluation and replacement by a qualified professional.

(4) Three cracked tiles were noted at the main roof. This can be a potential leak condition. Recommend further evaluation and replacement by a qualified professional.

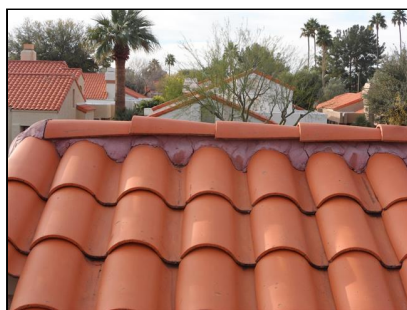
(5) Cracked mortar caps were noted at the main roof. This can be a potential leak condition. Recommend further evaluation and repair by a qualified professional.

(5) Cracked mortar caps were noted at the main roof. This can be a potential leak condition. Recommend further evaluation and repair by a qualified professional.

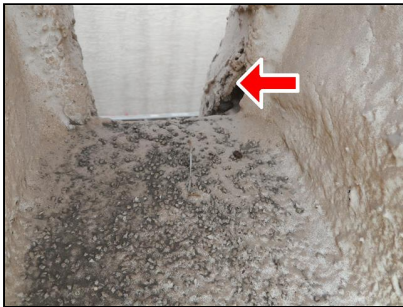
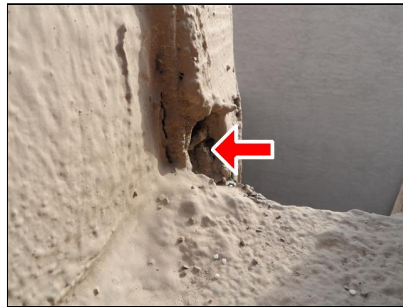
(1) Openings were noted at the roof scuppers. This is a potential leak issue into the walls. Recommend further evaluation and repair by a qualified professional.

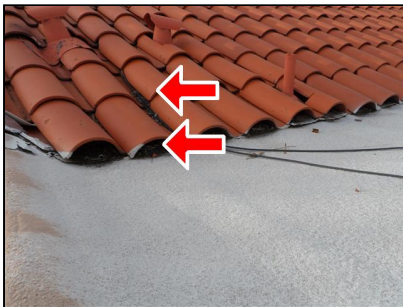
(2) Vegetation and debris were noted at the tile roof valleys. This condition can be conducive to leaks due to poor drainage from the debris. Recommend further evaluation and cleaning of the roof and flashings.

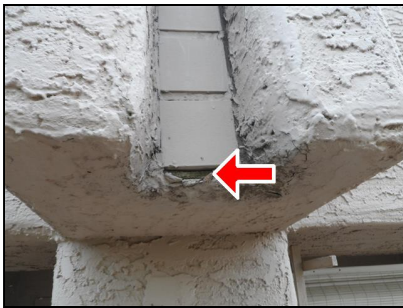
(1) Openings and moisture damage was noted at the scuppers down flow against the tile and stucco. Recommend repair and extending the scupper to not drain down the side of the wall by a qualified professional.

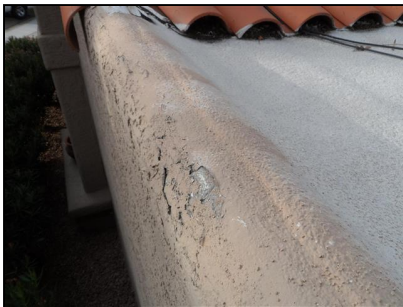
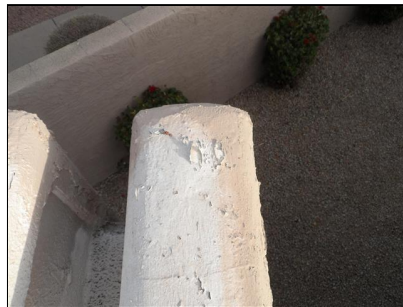
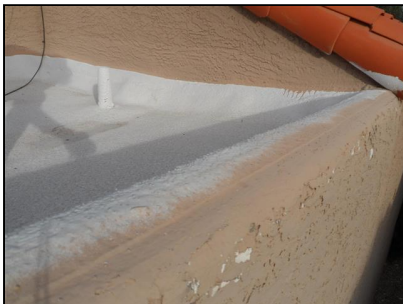
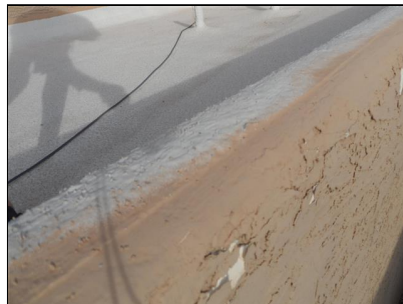
(2) Cracks and openings were noted at the roofs parapet walls. The openings can lead to moisture intrusion into the walls. Recommend further evaluation and repair by a qualified professional.

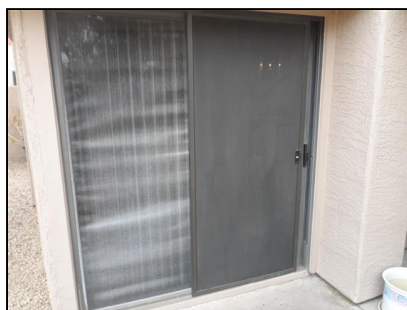
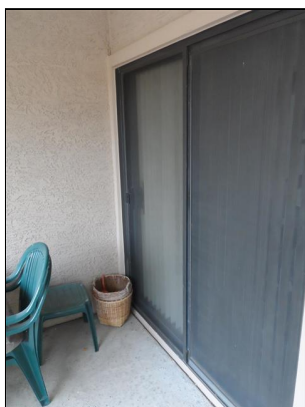
Two screen doors were noted difficult to operate at the porch. Recommend further evaluation and repair by a qualified professional.

Two screen doors were noted difficult to operate at the porch. Recommend further evaluation and repair by a qualified professional.

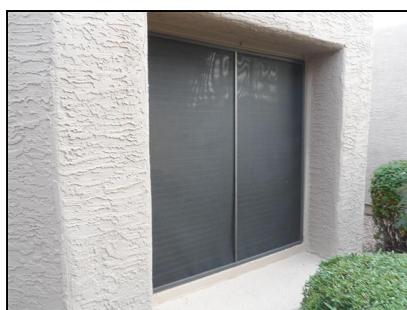
(1) Sun screens were noted installed at the windows. As a result, the screens prevent visibility to possible damage. Recommend buyer conduct a thorough inspection prior to close.

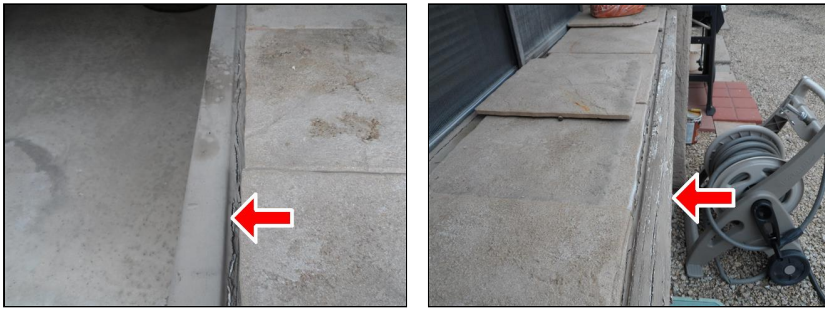
(1) The patio wood counter top was noted weather worn. Recommend repair as needed.

(1) The patio wood counter top was noted weather worn. Recommend repair as needed.

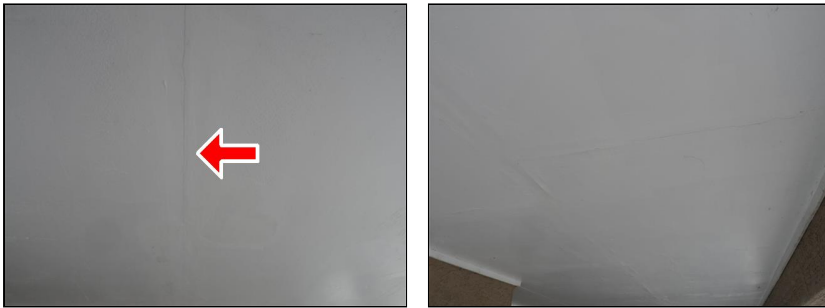
(2) Cracks were noted at the drywall at the porch covered ceiling. Recommend further evaluation and repair.

(2) Cracks were noted at the drywall at the porch covered ceiling. Recommend further evaluation and repair.

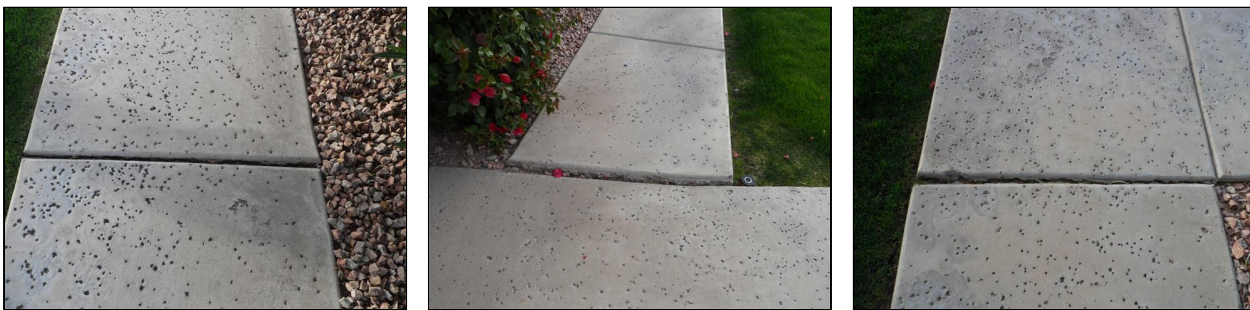
(1) An uneven walkway was noted at the front elevation. This is a potential trip hazard. Recommend further evaluation and repair by a qualified professional.

- (1) An uneven walkway was noted at the front elevation. This is a potential trip hazard. Recommend further evaluation and repair by a qualified professional.

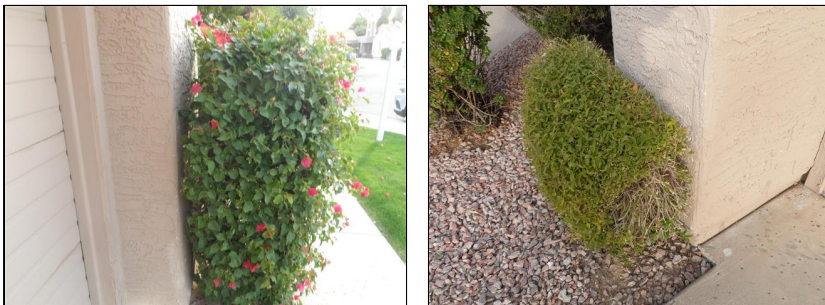
(2) Vegetation was noted in contact with the wall at the south elevation. Recommend cutting back all vegetation to prevent pest intrusion and damage to the wall.

(2) Vegetation was noted in contact with the wall at the south elevation. Recommend cutting back all vegetation to prevent pest intrusion and damage to the wall.

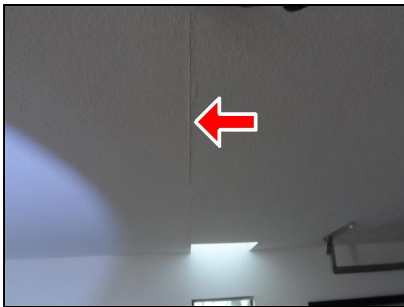
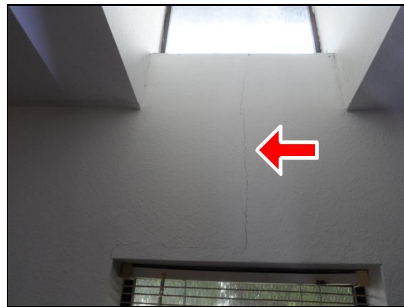
Minor cracks were noted at the wall and ceiling at the garage. The cracks are due to settlement or the attic space is being used as storage. Recommend further evaluation and sealing / repairing the cracks as needed.

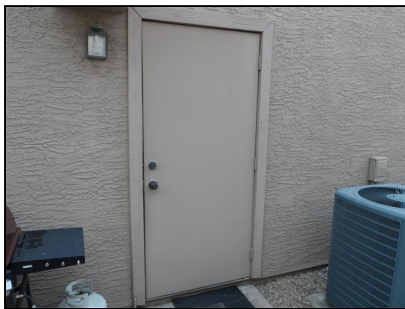
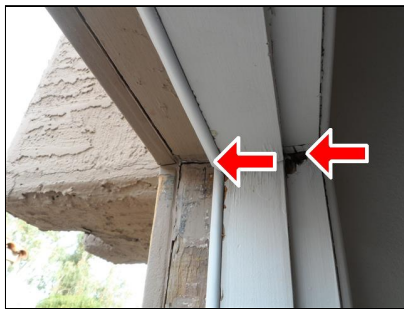
(1) The garage side door was noted installed backwards and also has moisture damage at the frame. Recommend further evaluation and repair by a qualified professional.

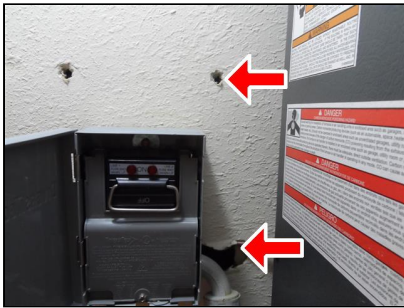
Air handler closet

Openings and minor damage were noted at the interior walls at various elevations. Recommend sealing and repair.

Openings and minor damage were noted at the interior walls at various elevations. Recommend sealing and repair.

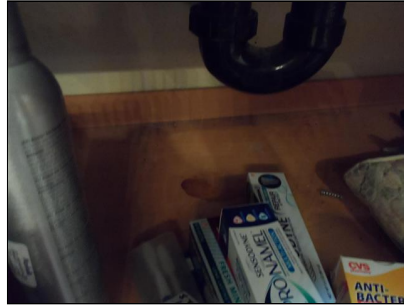
(2) Moisture stains were noted under multiple sink cabinets. The stains appear to be due to a prior leak condition. Recommend repair by a qualified professional.

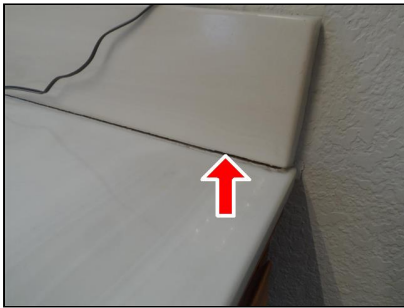
Owners bathroom

(3) Openings were noted at the bathrooms counter tops, this could allowing moisture intrusion into the cabinets below. Recommend repair.

(3) Openings were noted at the bathrooms counter tops, this could allowing moisture intrusion into the cabinets below. Recommend repair.

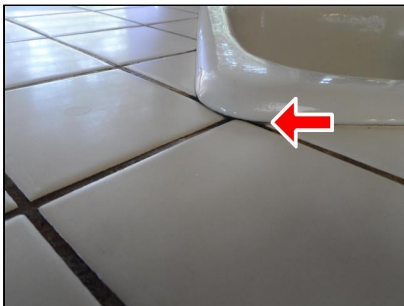
(4) Openings were noted at the kitchen sink counter. Recommend sealing.

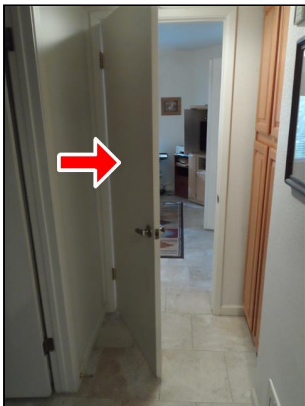
A interior door was noted self closing at the hallway. Recommend repair.

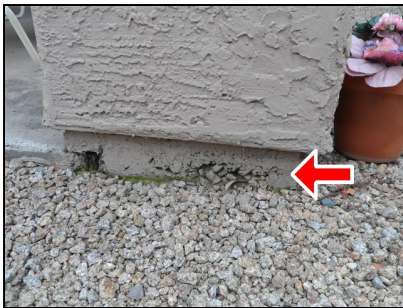
North elevation

Spalling was noted at a exterior columns footers. Cracks and spalling are typically due to inadequate or poor drainage. Recommend repair to the spalling by a qualified professional

Spalling was noted at a exterior columns footers. Cracks and spalling are typically due to inadequate or poor drainage. Recommend repair to the spalling by a qualified professional

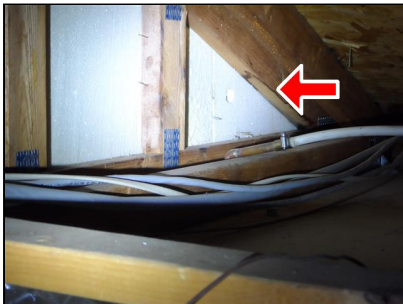
(1) Moisture stains and evidence of prior leak conditions were noted at the attic exterior wall framing. The stains are due to prior leaks. Recommend further evaluation and repair by a qualified professional.

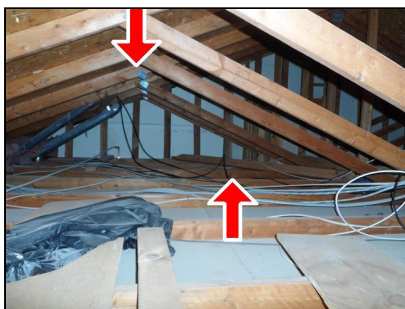
(2) A engineered truss was noted damaged at the attic. Repairs need to be certified by a certified engineer with documentation post at the repair. Recommend further evaluation and repair by a qualified professional.

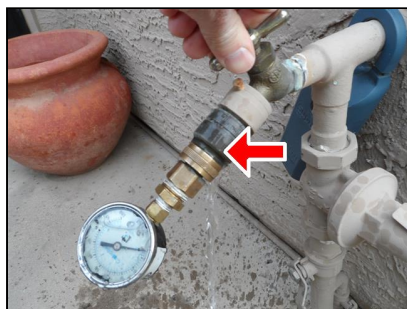
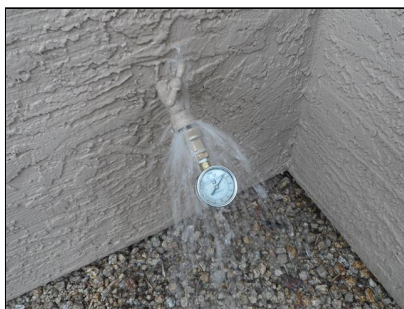
(1) Leaks were noted at both hose faucets during operation preventing from measuring the house water pressure. Recommend repair or replacement by a qualified professional.

- (1) Leaks were noted at both hose faucets during operation preventing from measuring the house water pressure. Recommend repair or replacement by a qualified professional.

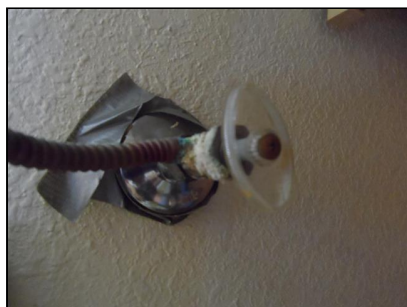
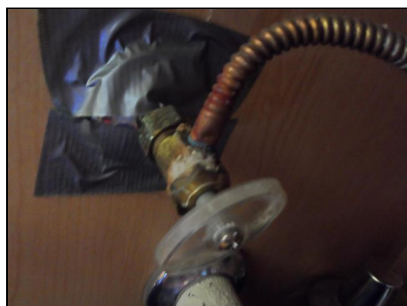
(2) Corrosion was noted at multiple interior valves at various elevations. No active leak was noted but this condition can result in leaks. Recommend further evaluation and repair by a qualified professional.

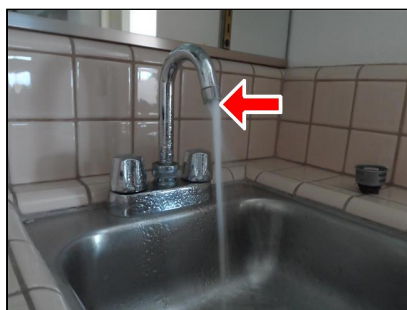
(3) Poor spray pattern was noted at the wet bar sink. Recommend repair.

(3) Poor spray pattern was noted at the wet bar sink. Recommend repair.

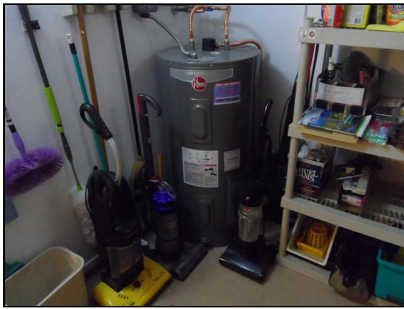
Data tag

(1) The Rheem 50 gallon electric water heater is 6 years old and was tested in operational condition at the time of inspection. Recommend asking the seller to provide any invoices or warranty information on the unit prior to close.

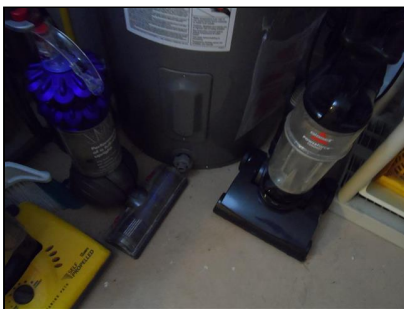
(3) The interior installed water heater tank does not have a drip pan or routed exterior drain pipe attached. Recommend the installation of a drip/overflow pan and exterior drain pipe by a qualified professional.

(3) The interior installed water heater tank does not have a drip pan or routed exterior drain pipe attached. Recommend the installation of a drip/overflow pan and exterior drain pipe by a qualified professional.

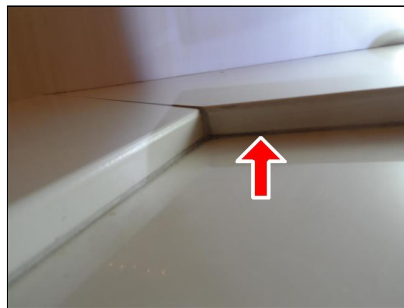
Loose

(1) Minor cracks and openings were noted at the owners shower tub, A wall panel was noted loose at the wall. Recommend further evaluation and repair.

(1) Minor cracks and openings were noted at the owners shower tub, A wall panel was noted loose at the wall. Recommend further evaluation and repair.

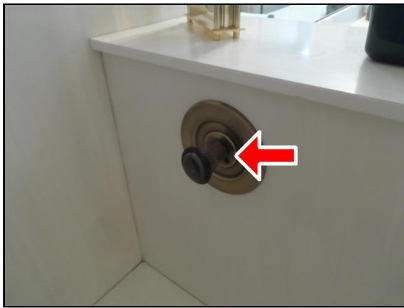
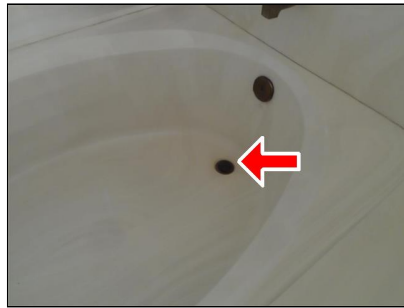
(2) The owners water system and fixtures were not tested due to the handle and pop up stop being seized. Recommend further evaluation and repair by a qualified professional.

- (2) The owners water system and fixtures were not tested due to the handle and pop up stop being seized. Recommend further evaluation and repair by a qualified professional.

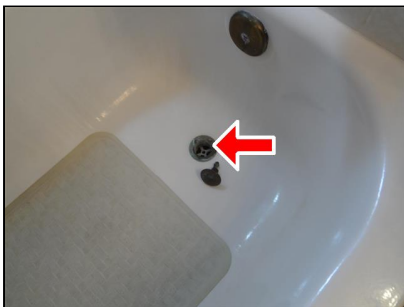
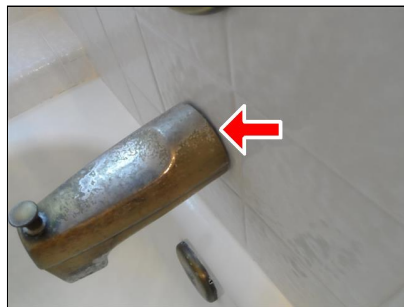
(3) The guest bathroom shower / tub was noted with cracks and openings and a pop up stop not installed. Recommend further evaluation and repair.

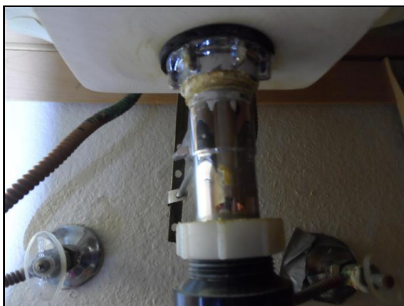
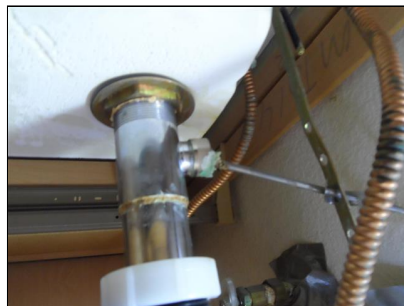
Corrosion was noted at multiple sink drain pipes at various elevations. No active leaks were noted but this condition can result in leaks. Recommend further evaluation and repair by a qualified professional.

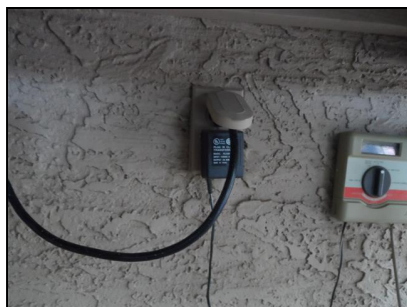
(1) A exterior electrical outlet was noted not having proper weather protectors installed at the patio. Recommend replacing by a qualified professional.

(1) A exterior electrical outlet was noted not having proper weather protectors installed at the patio. Recommend replacing by a qualified professional.

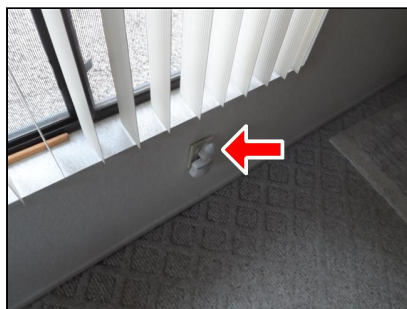
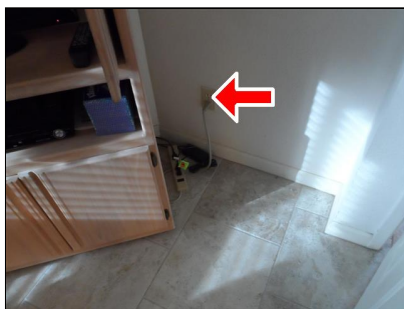
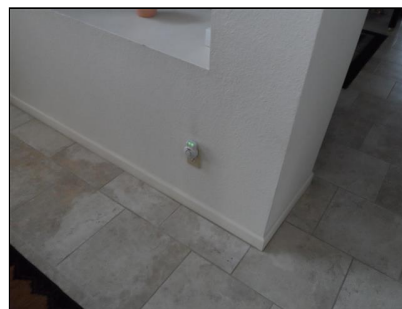
(2) Multiple electrical outlets were noted loose at the wall throughout the home. Recommend further evaluation and repair by a qualified professional.

(2) Multiple electrical outlets were noted loose at the wall throughout the home. Recommend further evaluation and repair by a qualified professional.

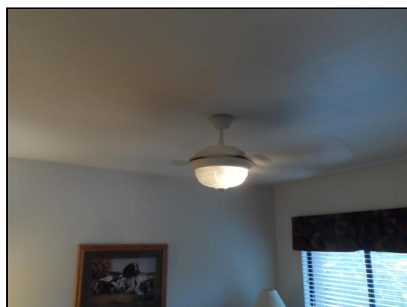
(3) A fan was noted having a slight wobble in the guest bedroom. Recommend further evaluation and repair by a qualified professional.

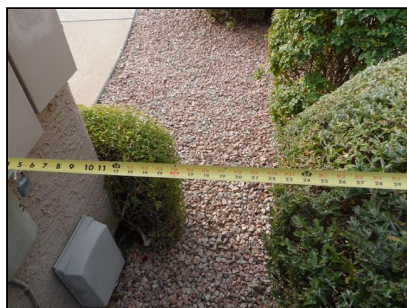
(1) Electrical service panels require a minimum clearance for work space in front of the panel of at least 48 inches for electrical safety. Recommend cutting back or removing the vegetation in front of the panel.

(1) Electrical service panels require a minimum clearance for work space in front of the panel of at least 48 inches for electrical safety. Recommend cutting back or removing the vegetation in front of the panel.

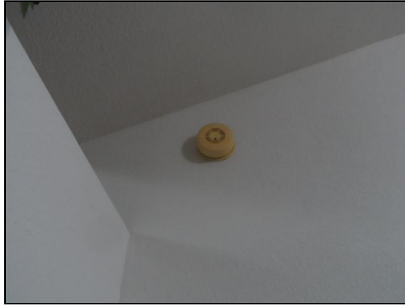
Only one smoke detector was noted installed in the house. Smoke detectors are required for fire safety. Recommend the installation of smoke detectors to present day codes in all rooms.

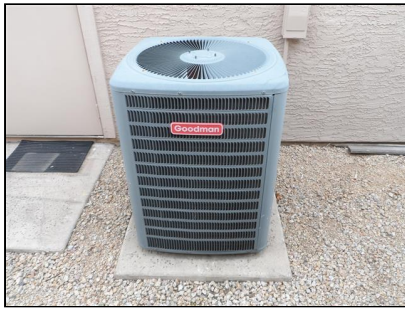
Data tag

Goodman A/C heat pump model # GSH130361AD, 3 ton cooling, is 14 years old and was tested mechanically operational but not considered to be efficient. Recommend further evaluation and repair by a qualified professional.

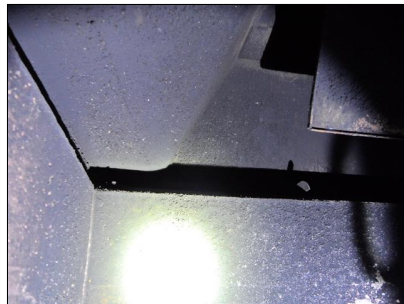
The flue for the fireplace was noted with a built up of soot and not completely visible for inspection. Recommend further evaluation and an annual cleaning by a qualified professional.

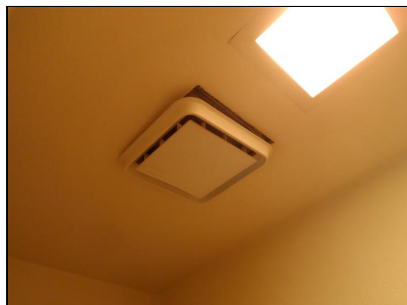
Laundry

(1) The laundry room fan was not operation at time of inspection. Recommend repair or replace by a qualified professional.

(1) The laundry room fan was not operation at time of inspection. Recommend repair or replace by a qualified professional.

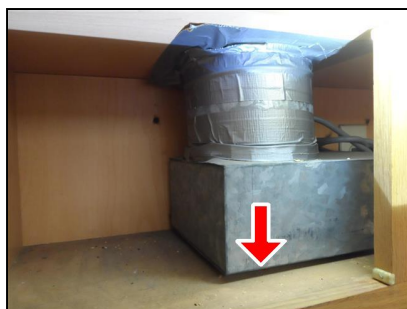
(2) The stove top ventilation was noted with air leaks at the cabinet. Recommend repair.

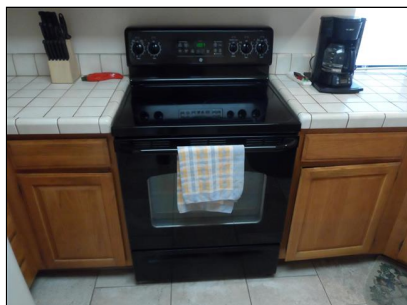
(1) The anti tilt guard was not installed at the stove. This is a potential safety hazard for small children as the stove can fall forward if climbed on. Recommend repair, installation of a tilt guard by a qualified professional.

(1) The anti tilt guard was not installed at the stove. This is a potential safety hazard for small children as the stove can fall forward if climbed on. Recommend repair, installation of a tilt guard by a qualified professional.

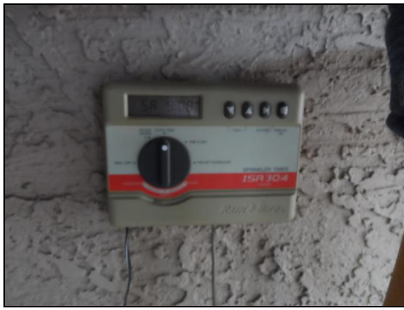
Was operational at the time of inspection.
