PROPERTY INFORMATION

Street Address: 123456 Main Street
City: Phoenix **State:** AZ **Zip Code:** 85004

Client Name(s): John and Mary Homeowner
VHI Report # 98556
Inspected By: Dennis D. Inspector - Certification #11111

Company Name Valley Home Inspections
Company Address 535 West Iron Avenue
Suite 122
City Mesa **State** AZ **Zip** 85210

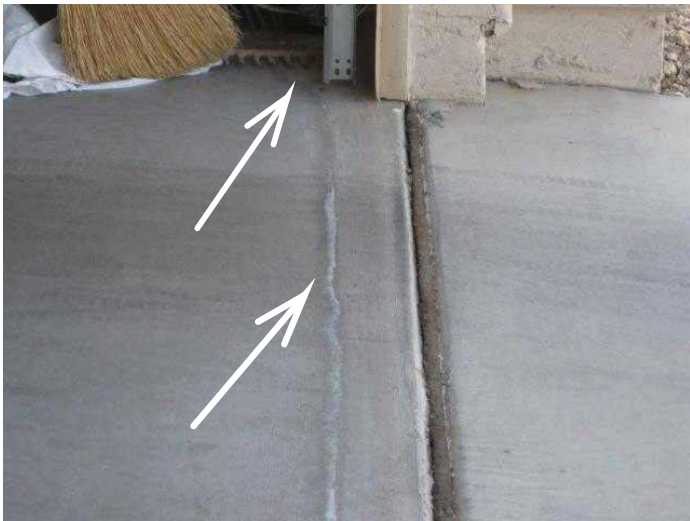
Evidence of water entering garage under door

- 4. Ceiling:** Drywall
Common settlement cracking was observed at the ceiling, which voids fire rating. Suggest repair as needed to re establish proper fire rating.
- 5. Garage Door(s):** Metal Roll Up
Evidence of water entering under the double door is present. Suggest further evaluation of the door seal and repair as necessary.
- 6. Service Door:** Metal
Evidence of water entering under the door was observed. Suggest repair as necessary.

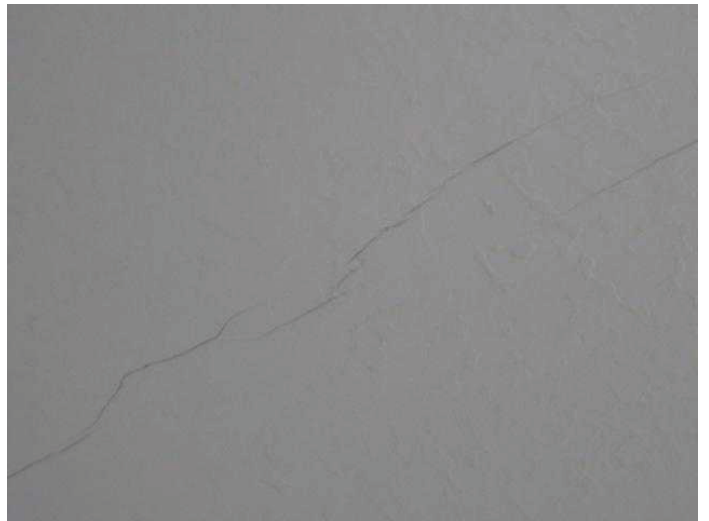
Cracking at garage ceiling

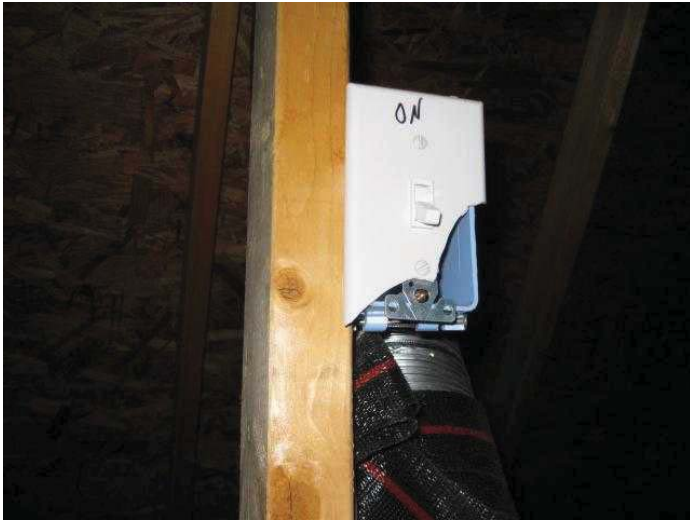
Broken light switch cover at the attic

Damaged switch cover at the attic. Replace as necessary.

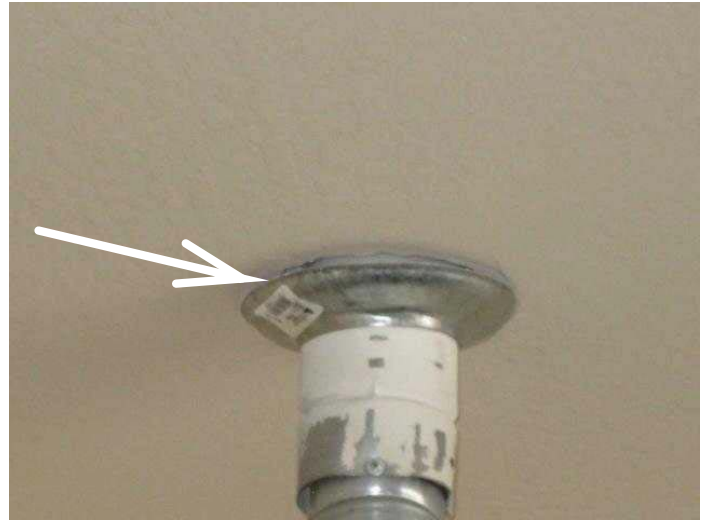
Water heater flue pipe fire ring not properly secured at the garage ceiling

Fire stop/fire ring not properly secured at ceiling penetration noted.
Recommend correcting to ensure proper fire rating of garage space. |

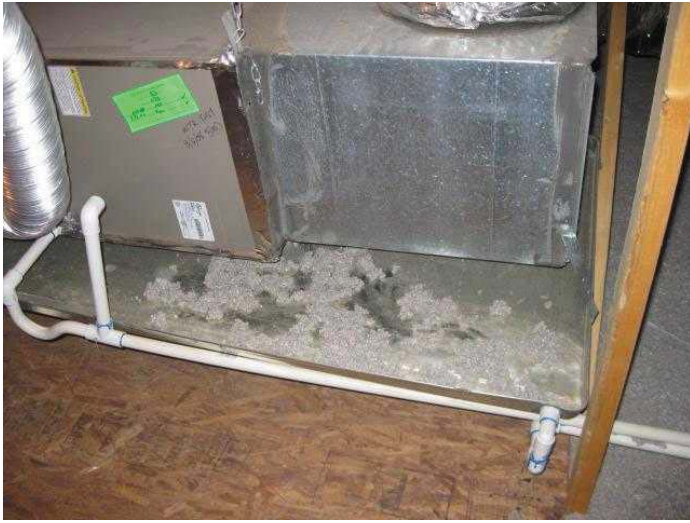
Insulation in A/C condensation drain pan at the attic

There is insulation in the A/C condensation drain pan at the first air handler. Suggest removal to prevent the drain from becoming obstructed.
